CARR-75

Samuel McKinstry Mill House
McKinstry's Mill

1849

**Maryland Historical Trust
State Historic Sites Inventory Form**

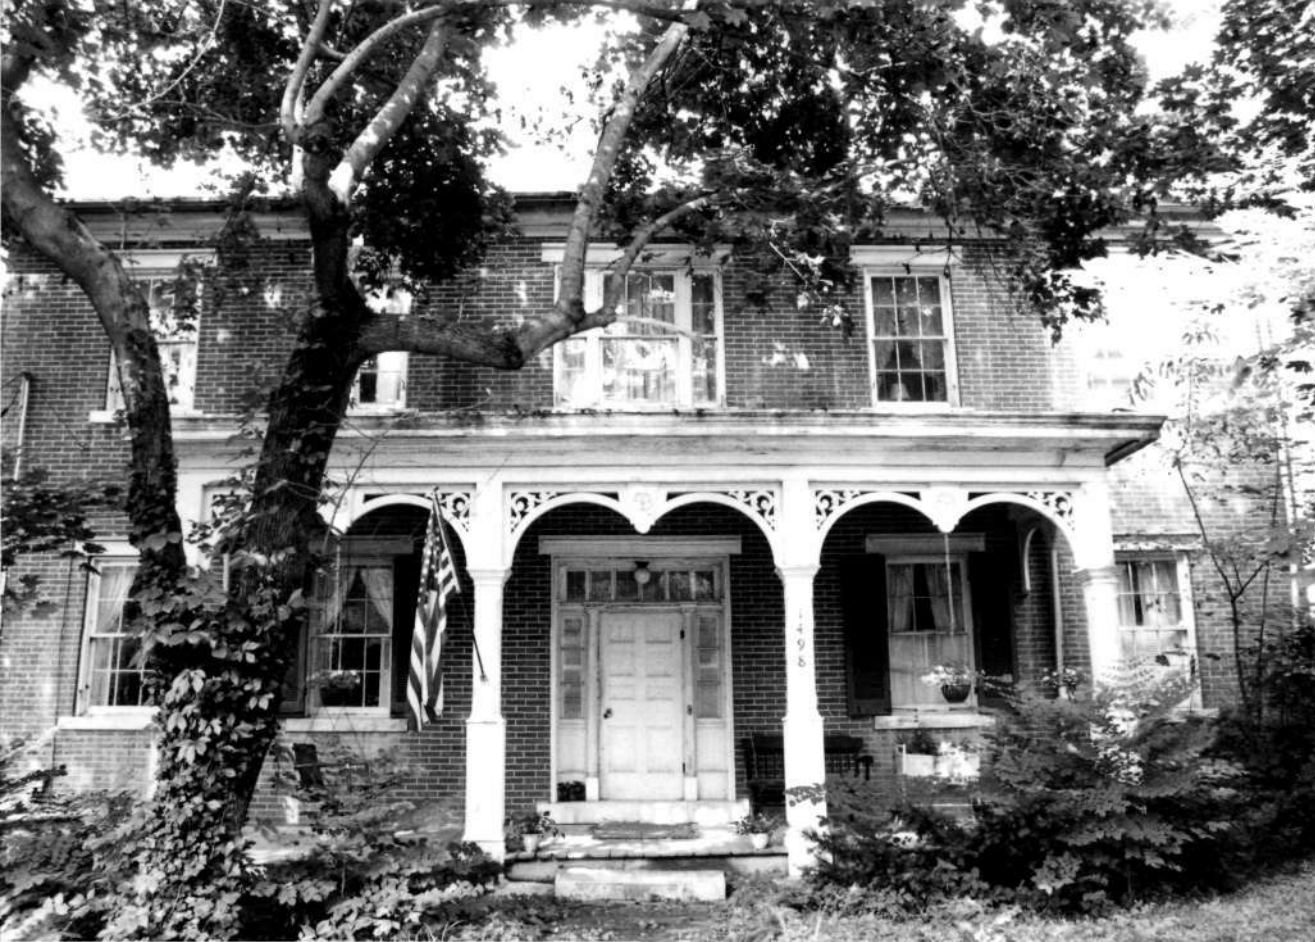
1/12

Neg. loc.: Maryland Historical Trust
east elev.

five-bay by two-bay, two-story brick structure with a center passage plan, a rubble stone foundation, and a standing-seam metal gable roof with a north-south ridge. There is an interior brick chimney on each end. The east elevation has stretcher-bond brick. The first story has a center entrance with an eight-panel door. The two bottom panels are tall, though the other panels are square. The panels are sunk and flat, with a Greek ogee panel mould and a raised margin applied to each panel. The door has a marble sill, side lights with three lights over one panel, and a six-light transom. The door is flanked on each side by a fluted Greek Doric column. The head rail has a Greek ogee. The soffit has three panels and jambs have one panel at the transom level and four panels at the door level which align with those on the door. These panels are identical to those on the door. The door frame has a bullnose moulding. There is a wood lintel with projecting cornice trim and a Greek ogee-and-bead bed mould. The center doorway is flanked on each side by two 6/6 double-hung sash with marble sills, bullnose frames and lintels and trim identical to the doorway. The windows have exterior blinds, though some of the blinds have been removed. The foundation has diamond-in-section wood louvers in a mitered frame between the south and south-center bays. The stonework surrounding this opening has a smooth-cut face but irregular edges. It appears to be marble. Most of the front foundation is, in fact, ashlar, limestone or marble. There is another opening in between the north and north-center bays, but it is not possible to tell now what is in it because it is hidden by the porch. The porch is a one-story, three-bay structure centered on the east elevation. It has four square boxed posts on marble plinth blocks. The posts are narrower on the top half than at the bottom and have a cavetto moulding at the break. They also have chamfered corners on the top. The capital on each post has two smaller cavettos. There are also jigsawn foliate brackets and center pendant drops with a rosette on the outer face. The porch cornice frieze has a cavetto and ovolo moulding. The bed mould has a cavetto, an ovolo, and a cavetto. The wood box cornice has an ogee moulding and the roof has a half hip. The second story has a center tripartite window with a 6/6 sash in the middle and a 2/2 sash in each flanker. The mullions are paneled. The other four bays have identical 6/6 sash to those on the first story, with marble sills and identical lintels on all five bays. The wood box cornice has a Greek ogee-and-bead bed mould like those found on the window lintels.

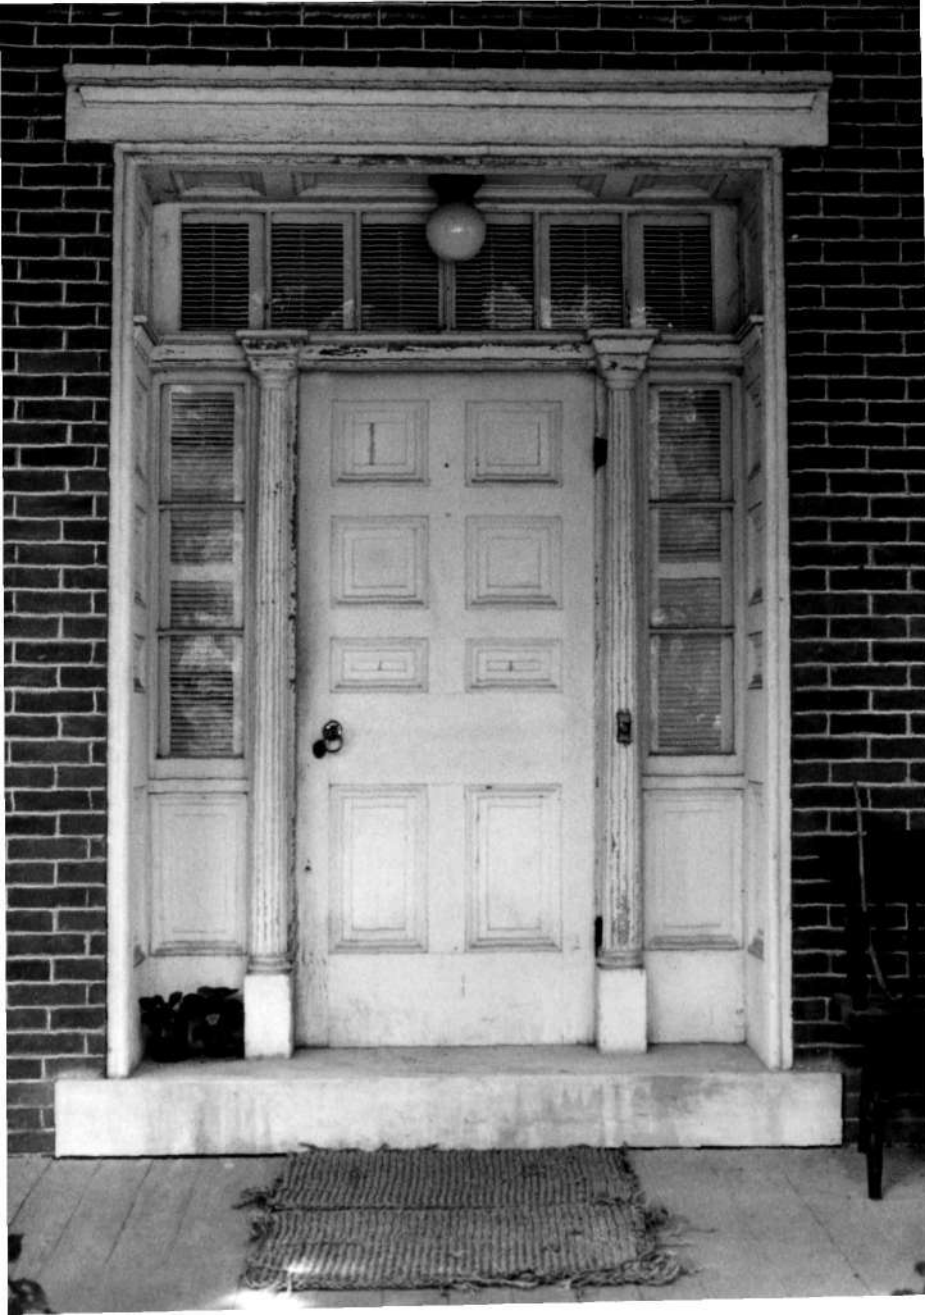
2/12

Neg. loc.: Maryland Historical Trust
east doorway

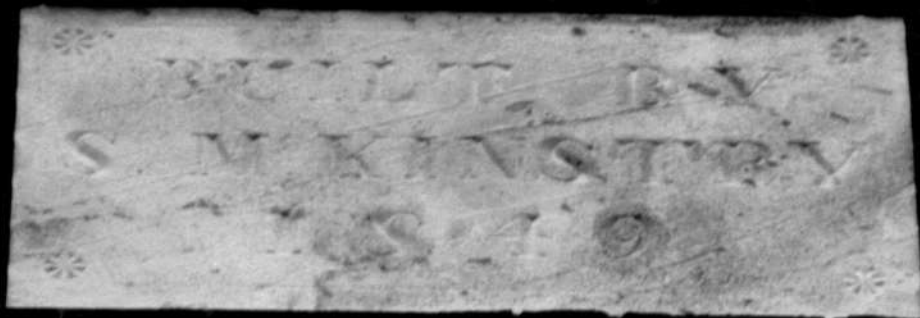
4/12

Neg. Loc.: Maryland Historical Trust
north elev. - date stone

The north elevation has Flemish bond brick. The foundation on this side is not exposed. Both the first and second stories have two typical 6/6 sash, one on each end. The gable end has two four-light sash in bullnose frames with marble sills. Over the window frames is a header course. There is a marble date plaque centered in the gable end. It is carved "Built by S.M^cKinstry 1849". In each corner of the plaque is a carved rosette.

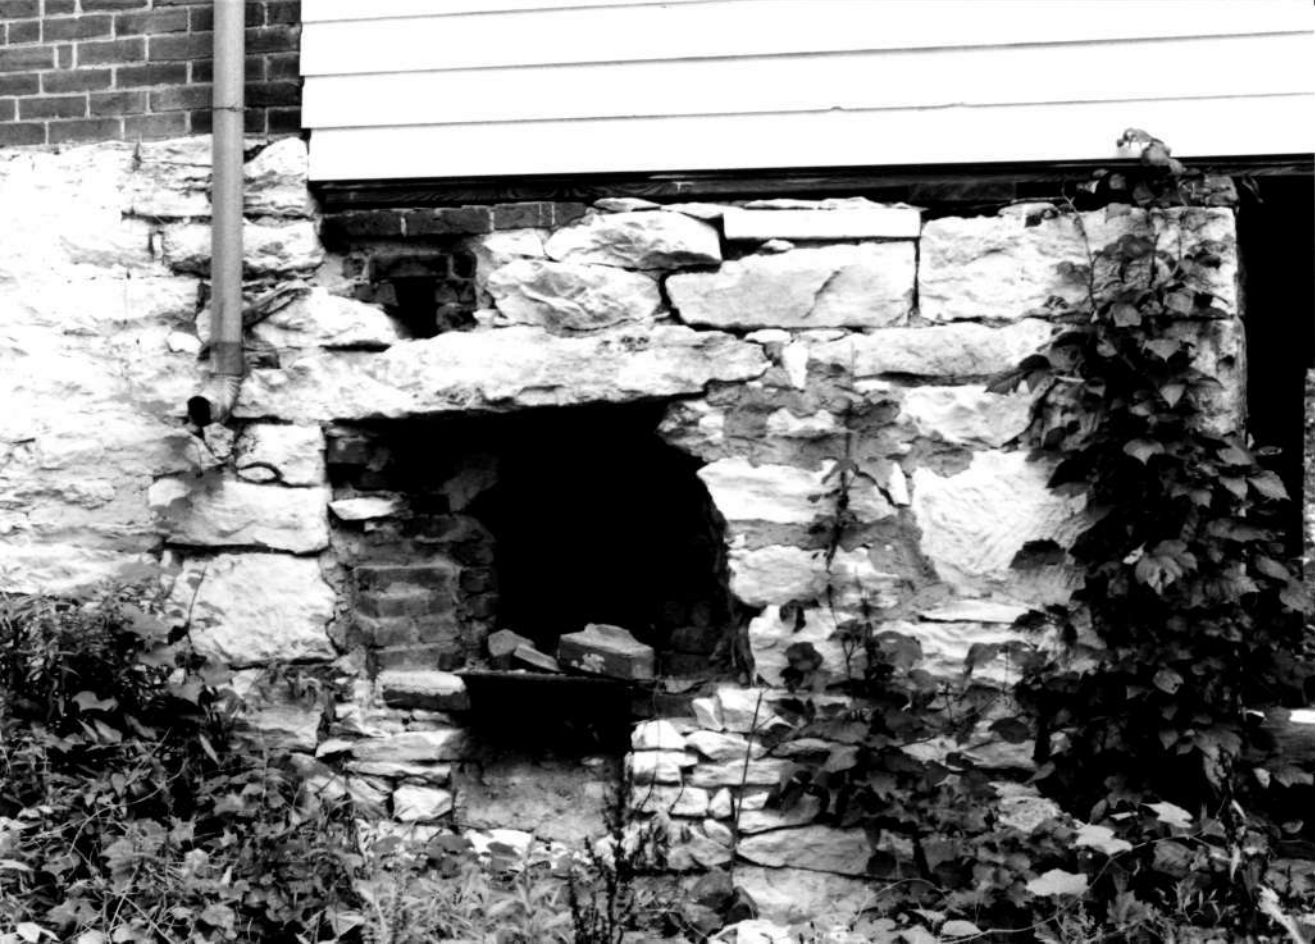
5/12

Neg. loc.: Maryland Historical Trust
west elev. bake oven opening

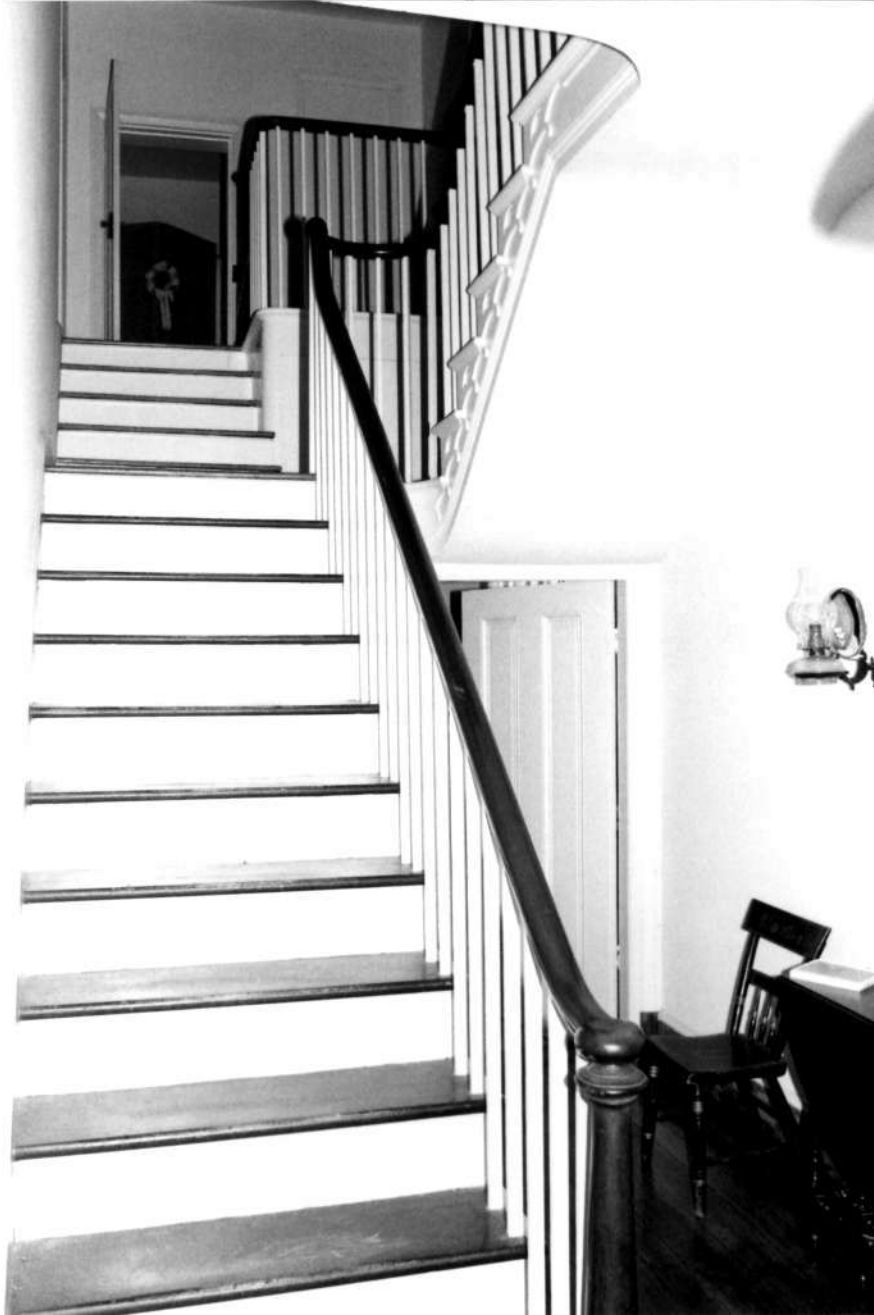
6/12

1st story stairway - view west

The newel post passes through the floor about one foot. It has a rectangular shank on the bottom that is narrower than the dimension of the post above the floor. This rectangular shank has a hole cut through it, with a wedge-shaped piece of flooring hammered into the hole which wedges it tight against the bottom of the floor. In front of the newel are two holes that are now plugged. There are circular marks on the front of the newel post as if there was a crank here that turned. Underneath the floor, attached to the bottom of the newel and underneath the two holes in the floor, are two pulleys. Apparently, there was some sort of control for the furnace that once stood in the cellar under the east end of the passage. Presumably, the crank was attached to wires that ran through the floor, around the pulleys, and to the furnace, possibly to open and close a duct.

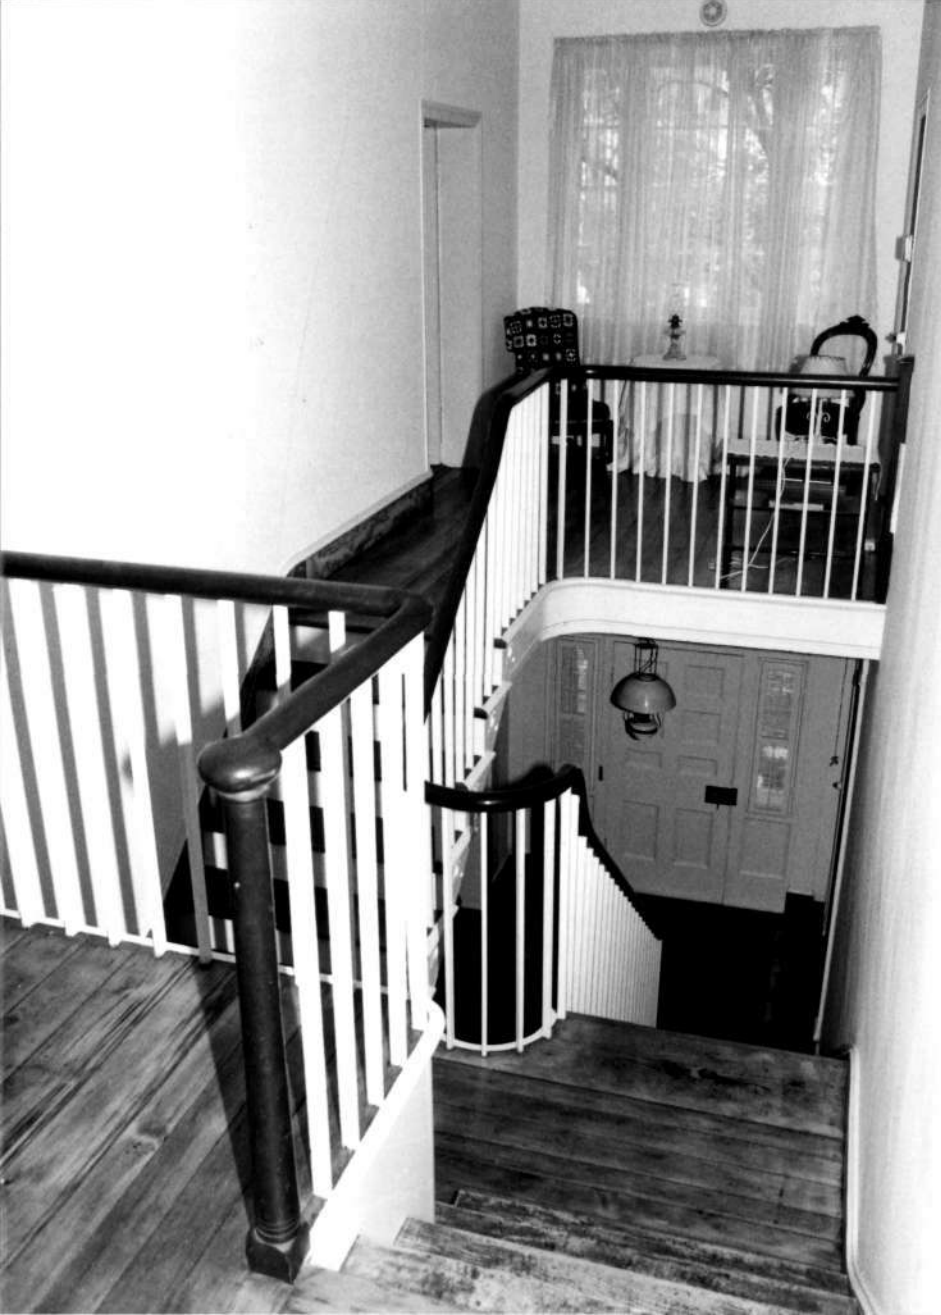
7/12

2nd story stairway - view east

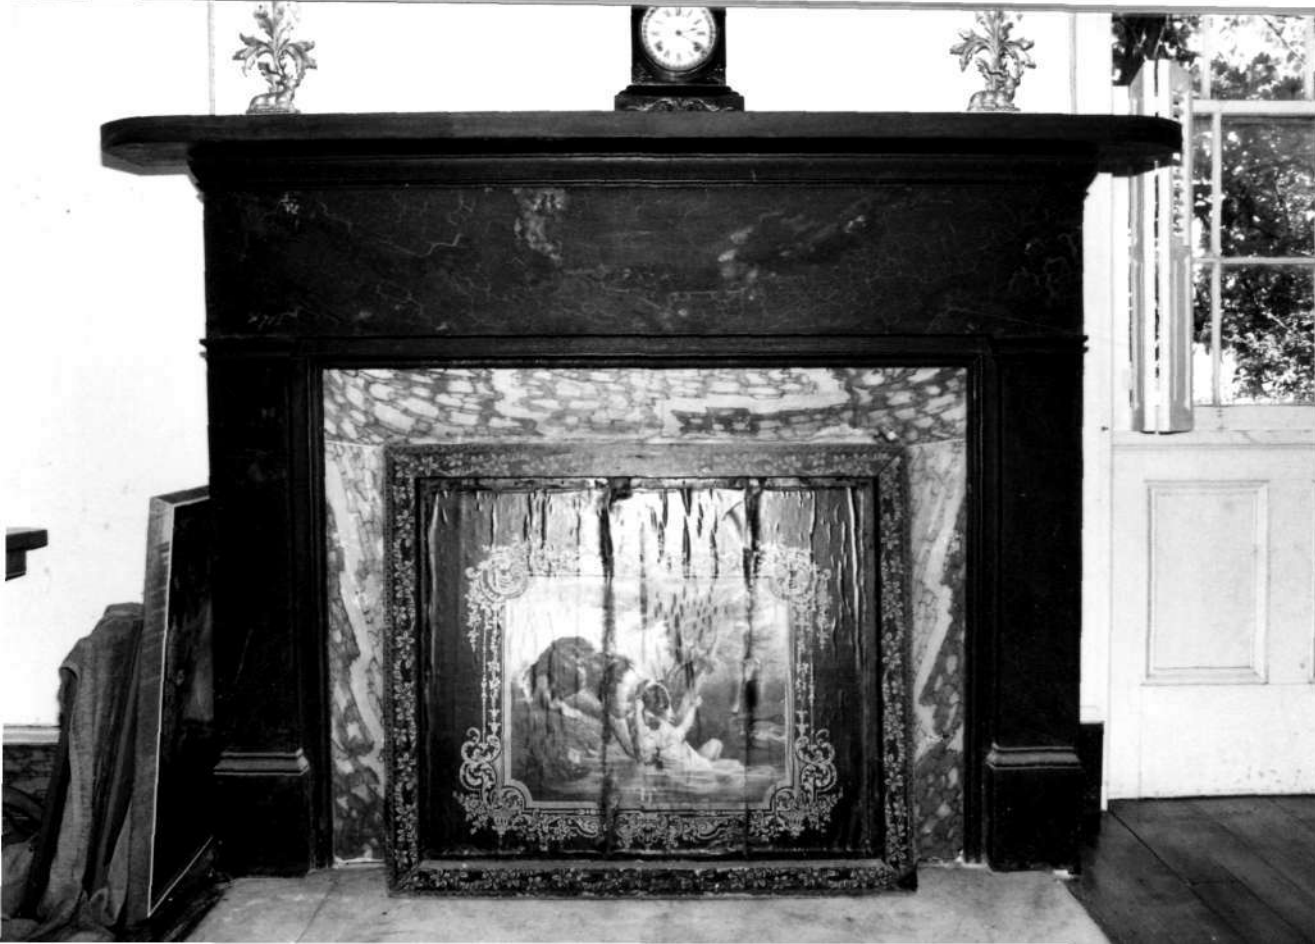
8/12

Neg. Loc.: Maryland Historical Trust
north room mantle

marble hearth and a marbleized wood mantle that is dark with gold veining. The mantle has pilaster strips with a Greek ovolo topped by a cavetto as the capital. The frieze is plain with a quirked Greek ogee-and-bead bed mould. The plaster surround is marbleized in rectangular patches that are similar to the marbleizing on the baseboards. The architraves in this room are identical to those in the passage, as are the marbleized baseboards. Below the windows are two flat, sunk panels with quirked Greek ogee-and-kick-panel moulds. The window jambs are splayed. Set over the fireplace is a fire screen that was found in the attic and is believed to belong to this fireplace. It has a wood frame with black background and gold transfer-printed floral and ribbon border. The center of the screen has a picture of a dog pulling a child from the water. It is printed on canvas and marked "Chez Bourgeois J^{le} a' Paris". The back of the screen appears to be asbestos. The door to this room has a plain cast iron rim lock.

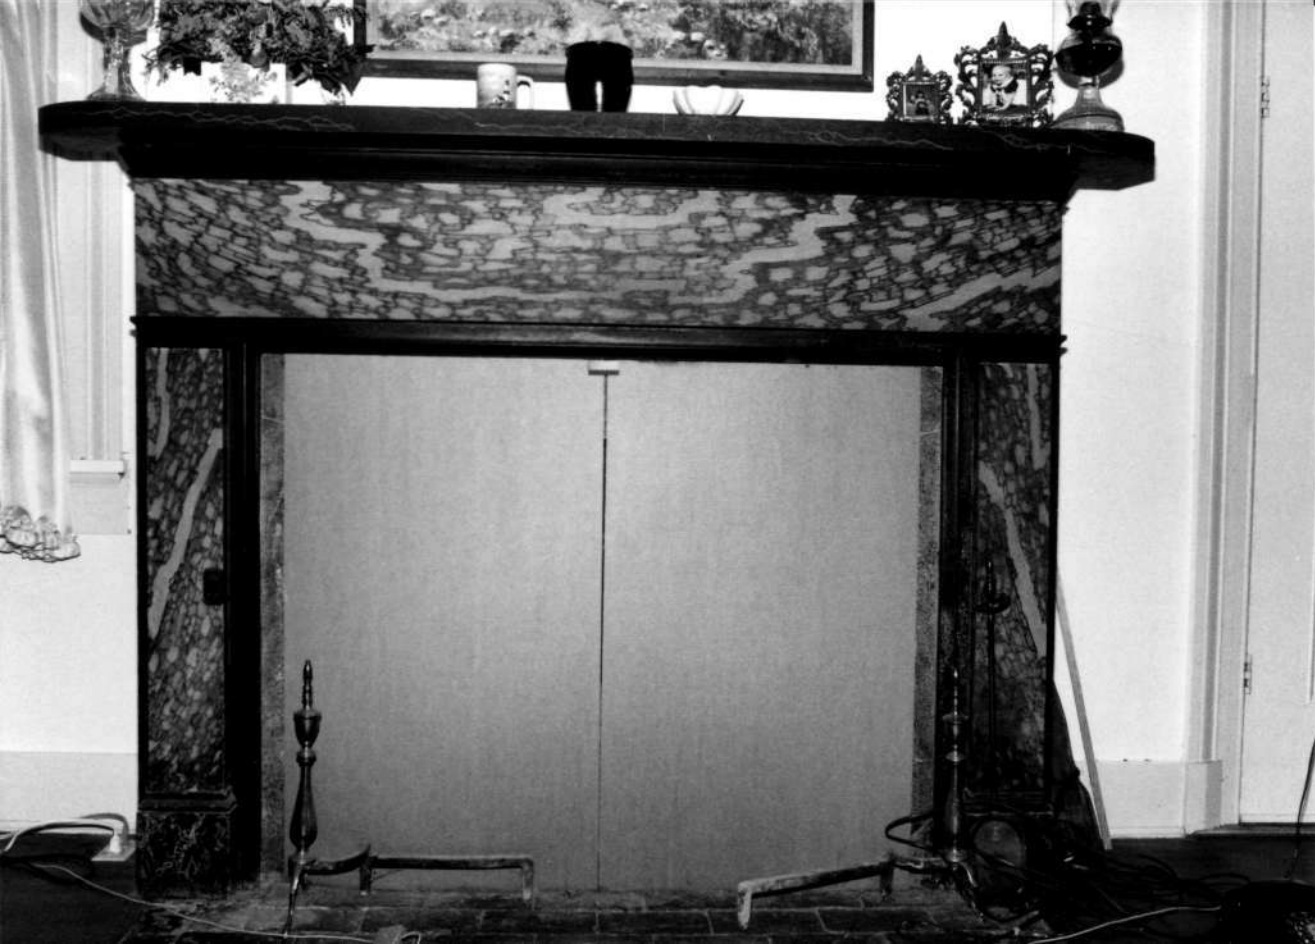
9/12

South room no. 116

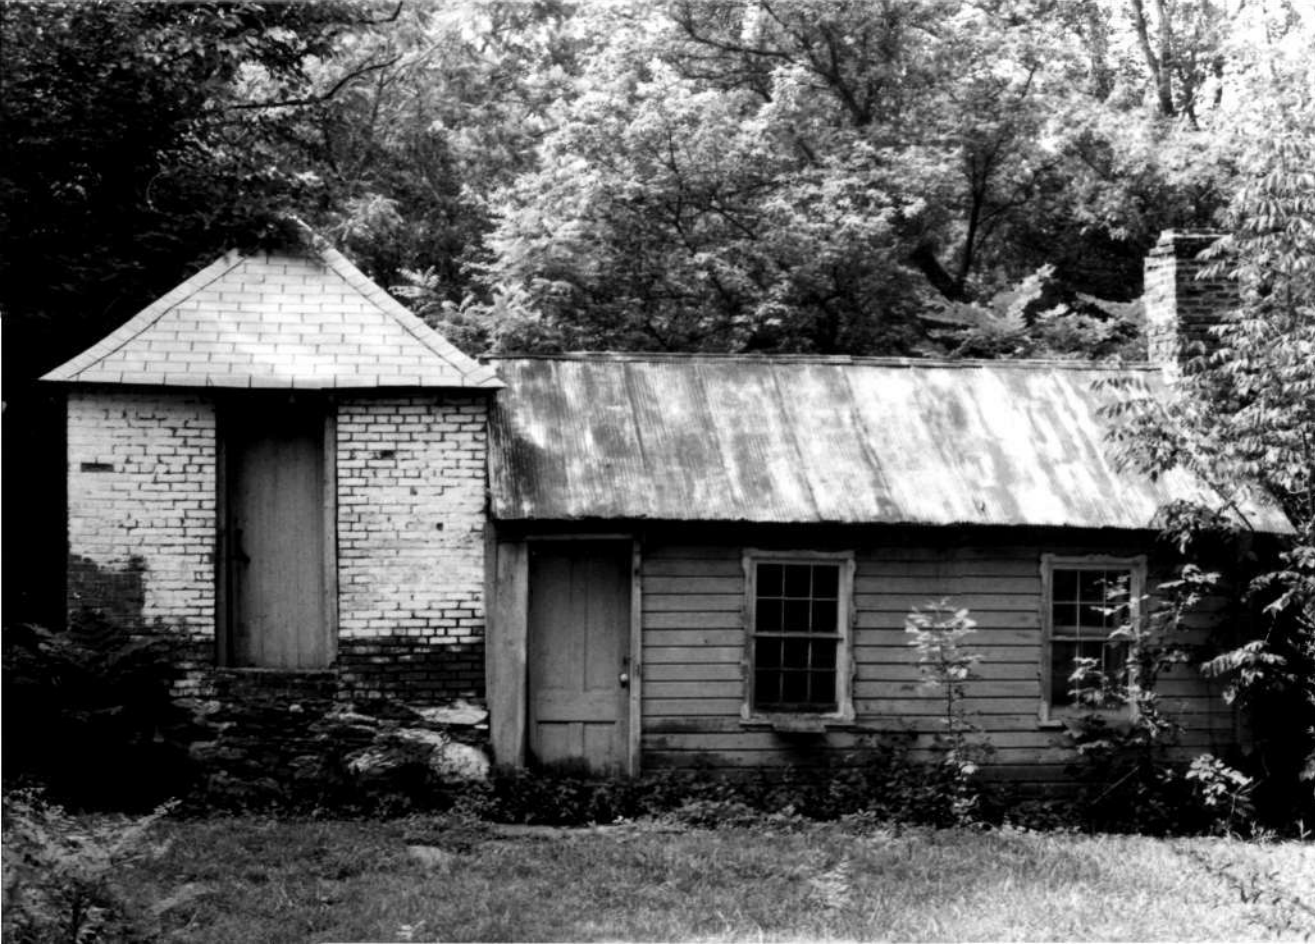
11/12

Neg. Loc. Maryland Historical Trust
Smokehouse & Summer Kitchen - north elev.

About 20 feet southwest of the house is a smokehouse with a rubble stone foundation of marble, slate, and Sam's Creek metabasalt. The walls are 5-to-1 common bond brick. The hip roof has asphalt shingles. The north elevation has a beaded-edge, vertical-board door in a circular-sawn frame. The door has a suffolk latch and cast iron butt hinges marked "J.GODDINGTON". The battens on the back of the door are dovetailed into the vertical boards. The east elevation has a diamond-in-section wood vent in a mortised-and-tenoned-and-pegged frame with a brick jack arch and a wood sill. The west elevation of the smokehouse has a summer kitchen attached to it with a boarded-up opening that was probably a vent identical to that on the east. The south elevation on the lower level has an opening that at one time had a door. There are no openings above. The smokehouse floor joists run east-west and the wood floor boards run north-south. There are circular-sawn horizontal members at the eave line. The rafters are sawn, but no tool marks are visible.

The summer kitchen on the west side of the smokehouse is a one-story, three-bay by one-bay structure of German siding with corner boards and a gable roof of corrugated metal with an east-west ridge. There is an exterior brick chimney on the west end. The north elevation has a four-panel door to the east and two 6/6 sash to the west with jigsawn-trim surrounds. The west and south elevations have no openings. The building is constructed of 2 x 4's. The fireplace on the west end has a segmentally-arched opening with two round steel bars acting as lintels under the arch. The fireplace has straight jambs and a pivoting crane on each side. About 60 feet southwest of the smokehouse is a hog pen with vertical-

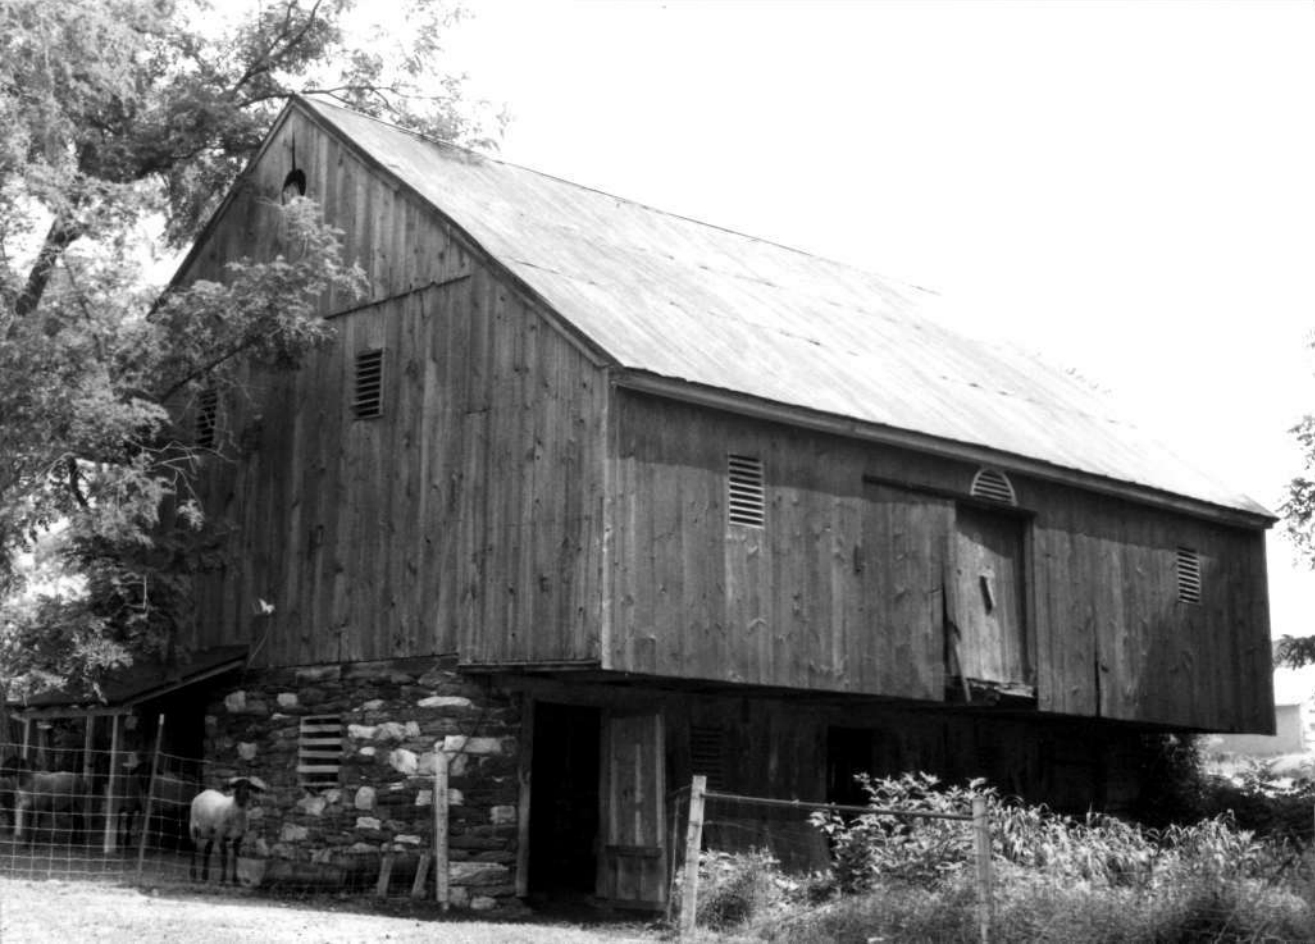
12/12

barn - south & west elevs.

About 30 feet northwest of the garage is a bank barn with a forebay that faces south. The south elevation on the lower story has vertical-board siding. From west to east there is a new door, a wood louvered vent, a door opening with pintles, a wood louvered vent, and a vertical-board Dutch door on strap hinges with rounded ends. The upper story has one vent on each side with a pair of doors in the center that has a semi-circular wood louvered vent above it. The southern ends of the joists under the forebay are notched on the top to hold the sill, which is pegged to some of the joists. The west elevation has a rubble stone lower story with a door opening to the north and two window openings to the south. There are two wood vents in the upper story with a round opening cut in the peak. The east elevation has a boarded-up window to the south and a new door in an original opening to the north in the lower story. The upper story has two wood vents, with a round wood louvered vent in the gabled peak. The north elevation has vertical-board siding. The gable roof has corrugated metal and an east-west ridge. The upper story has centered double wagon doors that are new, and an outshot attached to the east end of this elevation.
